# Manhole Inspection Summary

Manhole # S45MM\_015MH

Insp Date: **3/26/08 8:58 AM**

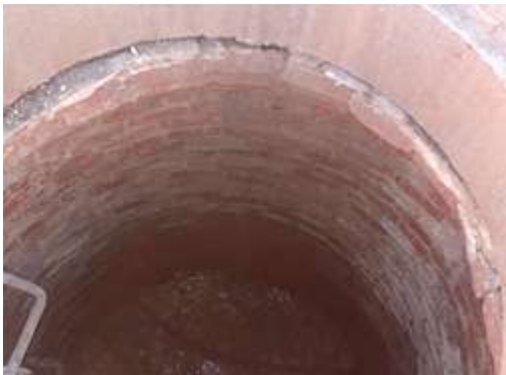
Defect 2

☒ **Leaks**

frame leaks

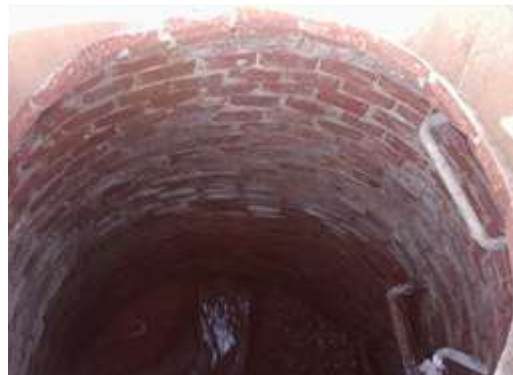
Defect 1

Infiltration: ☐ None ☐ Joint ☐ Cracks ☒ **Mortar** ☐ Roots ☒ **Wall**

adjustment joint

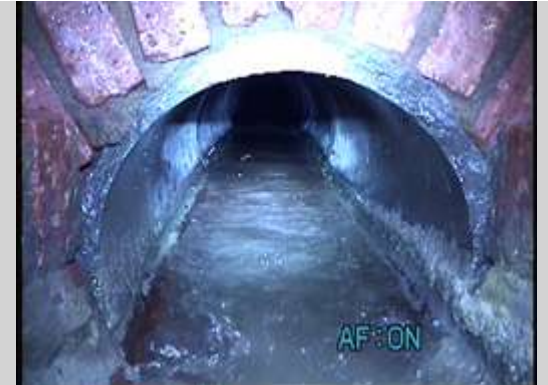
12 O'Clock Outflow

10 in. Circular Gravity Sewer  
Pipe Out @ 12 O'Clock

Pipe Height: **10.8** (in.) Rod and Bar (Angled)  
Pipe Material: **Clay** ☐ Pipe Lined  
Invert Depth: **9.70** (ft.) Flow Characteristics: **Fast**  
Deposits: ☒ None ☐ Mud ☐ Sludge ☐ **Debris** ☐ Grease  
Silt Depth: (in.) Deposits Extent:  
Infiltration: **None** Pipe Seal Cond: **Sound**

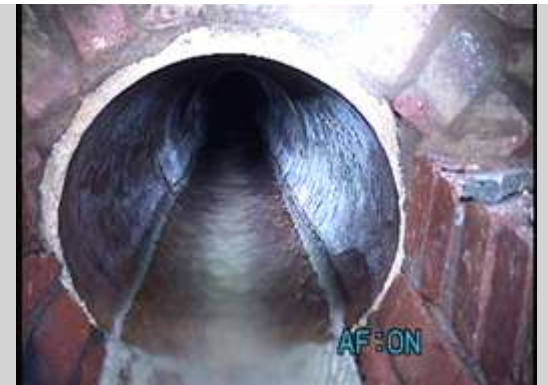
3 O'Clock Inflow

10 in. Circular Gravity Sewer  
Pipe In @ 3 O'Clock

Pipe Height: **10.8** (in.) Rod and Bar (Angled)  
Pipe Material: **Clay** ☐ Pipe Lined  
Invert Depth: **9.60** (ft.) Flow Characteristics: **Fast**  
Deposits: ☒ None ☐ Mud ☐ Sludge ☐ **Debris** ☐ Grease  
Silt Depth: (in.) Deposits Extent:  
Infiltration: **None** Pipe Seal Cond: **Sound**

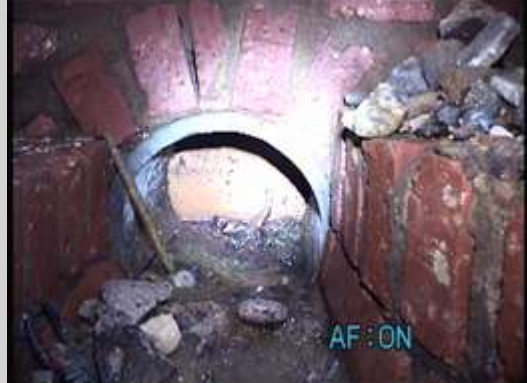
8 O'Clock Inflow

Deposits: ☐ None ☐ Mud ☐ Sludge ☒ **Debris** ☐ Grease

Silt Depth: **8** (in.) Deposits Extent: **Heavy**

Connects To: **Stub connection / abandoned**
